Notting Hill Housing

Windmill Park

Decentralised Heating Investigation Report

<b>Author:</b>	Mark Hutchison	<b>MH</b>
<b>Checker:</b>	Victoria Stoyanova	<b>VS</b>
<b>Approver:</b>	Justin Fletcher	<b>JF</b>
<b>Report Number:</b>	EMS071-01

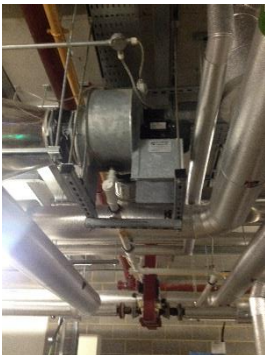
The system incorporates all necessary valves and incorporates an air/dirt separator and dosing pot.

The flue system has a flue fan incorporated within it that is constantly operating whenever any of the boilers are required to operate.

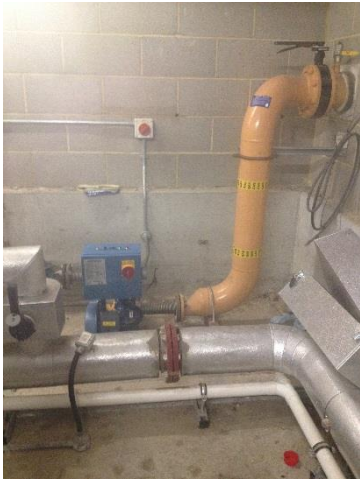
One principle difference with this energy centre is the provision of the gas booster unit which would not normally be required. The particular boilers that have been used have a requirement for gas to be delivered to the units at a minimum 25mbar. This is 5 mbar greater than the peak provided on the low pressure side of a standard gas meter and explains why a gas booster has been incorporated in to the system.

The flue includes an induction fan principally due to the horizontal length of the flue. It is not clear whether this was part of the original design due to the arrangement and location of the inverter that controls it. It should have been possible with better planning within the plant room to have avoided the need for this fan. As the fan is required to operate at every time the boilers are firing, there is an associated cost penalty in terms of energy usage that the fan incurs.

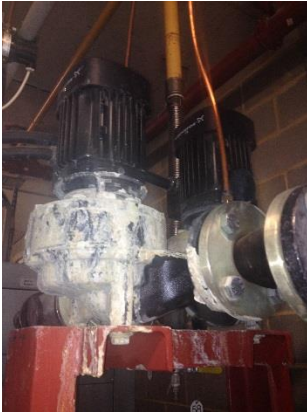
There has been a number of leaks within the system since completion and so the inhibitor chemicals and monitoring processes should be ongoing and to a level that would exceed the norm for a similar building without the leakage issues. Monthly checks on inhibitor chemical levels and quarterly chemical and bacterial analyses would be recommended.

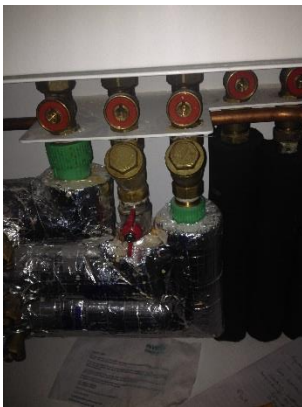
There are signs that the potentially poor water quality is having an effect on the system and there has been a number of pump failures and signs on site that glands continue to fail.

The system contains strainers, dosing pots and air/dirt separators that all assist in keeping a clean system. On the HIU's however the strainers are located *upside down* and therefore any debris collected whilst there is flow through the strainer is returned to the system via gravity when the flow is turned off such as when the strainer is isolated for maintenance.

There does appear to be an issue with water quality and it is recommended that a full chemical and biological analysis of the water be undertaken. The samples should be taken from a number of locations throughout the system. The strainers should be cleaned and any debris found should equally be analysed.

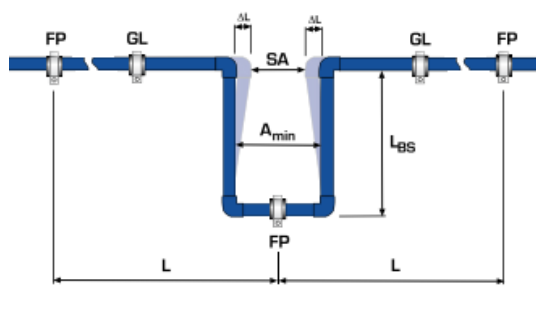
Pipework expansion would normally be addressed through a number of methods. Expansion loops in pipework as detailed on the diagram below is a typical method. Pipe offsets is another method that is similar to the diagram with half the expansion of that provided by the loop accommodated

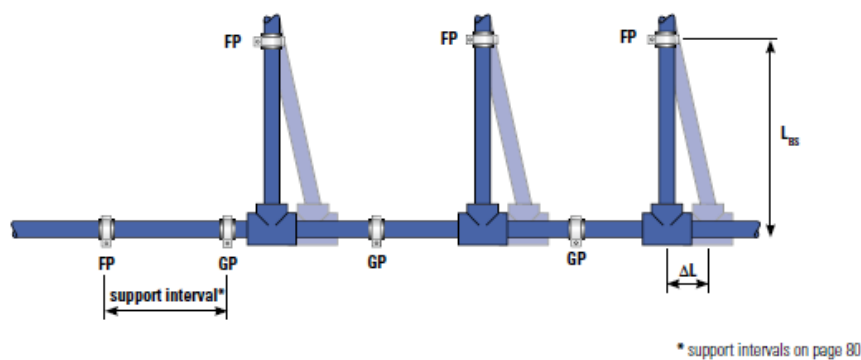
Using the same principle as direction changes, branches need to compensate for linear expansion in pipes. The manufacturer's detail below considers a continuous run of pipework branches.

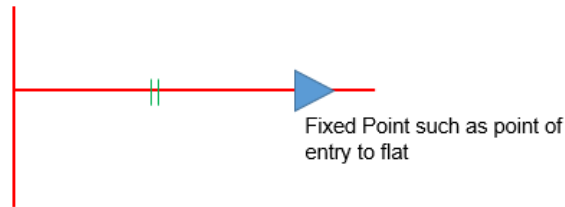
Arrangement as initially installed

The difference being that there are valves installed within the branch connections. The stress created by the expansion of the pipework is directly applied to the valve joints. The following details identify the stresses and the likely additional flexing that occurs at the valve junction.

In order to address this issue there will need to be a redesign of the pipework system within the corridor ceiling voids and possibly even pipework replacement as any reinforcement and fixing around the valves will lead to a lack of expansion accommodation in other areas.

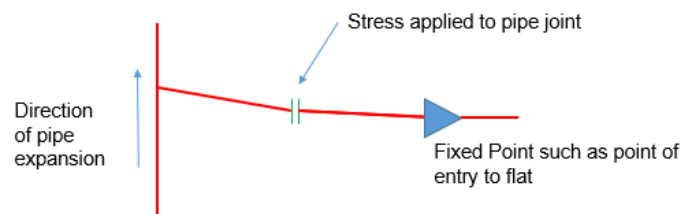
Stresses on Heat Up

It is apparent that the valve connections to the pipework system are not sufficiently robust to accommodate the stresses that are being applied to them. The lack of robustness results in leaks at the valve joints that are likely to occur both at times of original heat up and whenever the system is allowed to cool down.

As a temporary measure and where water is penetrating flats at times of system cool down, a puddle flange type arrangement can be used adjacent to the pipework entry in to the flat. This arrangement will assist in preventing water entering the flat but will not address the leaking from the valve joints in any way.

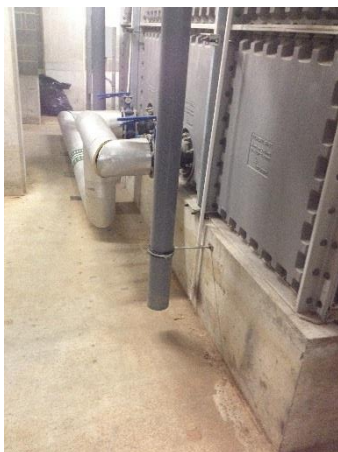
The break tank has a capacity of circa 21,000 litres and has magnetic water treatment unit connected to the incoming mains cold water service. Any water entering the tank therefore has a dwell time within the tank degrading the effect of the magnetic water treatment prior to its delivery to the site.

The tank itself has been mounted on a flat base. The sectional arrangement of the tank means that the base has internal flanges that present issues with being able to fully drain the tank. This is not an abnormal situation however in this instance there is a risen concrete base and by providing piers instead of a complete base would have permitted the preferable situation of an externally flanged tank with the added health and maintenance benefits of being able to fully drain the tank.

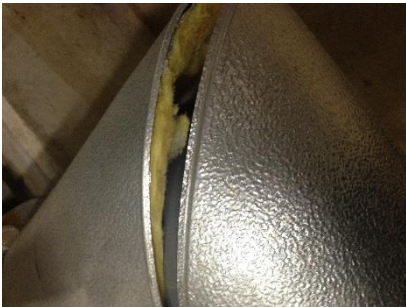
Where the metal cladding had separated at the junctions of the pipework within the energy centre it was apparent that the insulation thickness was insufficient to appropriately address the heat gain from the environment into the pipework system.

Further issues such as the insulation thickness to the cold water distribution pipework and the potential reduction in the water storage capacity should be detailed in the water risk assessment for the property.
